DEATH OF A BATTLESHIP
THE LOSS OF HMS *PRINCE OF WALES*
December 10, 1941

A Marine Forensics
Analysis of the Sinking

Garzke - Dulin - Denlay

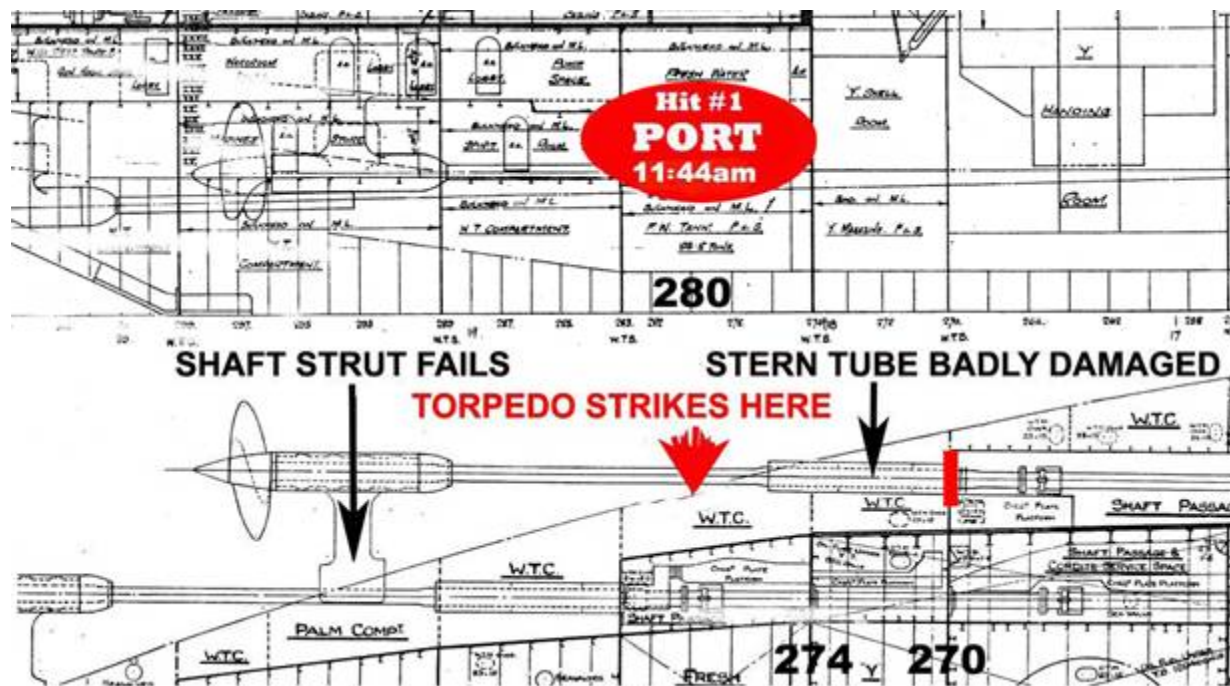
Figure 1 – Location of the First Torpedo Hit

The upper *profile view* shows where the first torpedo hit to port at about Frame 280, based on measurements made by the Expedition ‘Job 74’ diving team. The lower *plan view* shows the stern tube and the aft end of the outer shaft alley for the shafting from “B” Engine Room (upper shaft in plan view). The torpedo struck just abaft the stern tube, which in turn became disassembled from the shafting after the failure of the shaft strut. The explosion would have wrecked the structure of the nearest bulkhead (Frame 274) in the stern tube area and most likely caused serious damage to the bulkhead that closed off the aft end of the shaft alley (Frame 270 - red line). When the shaft began to rotate out of center it further damaged that bulkhead (Frame 270) and later demolished it when the shafting came apart.

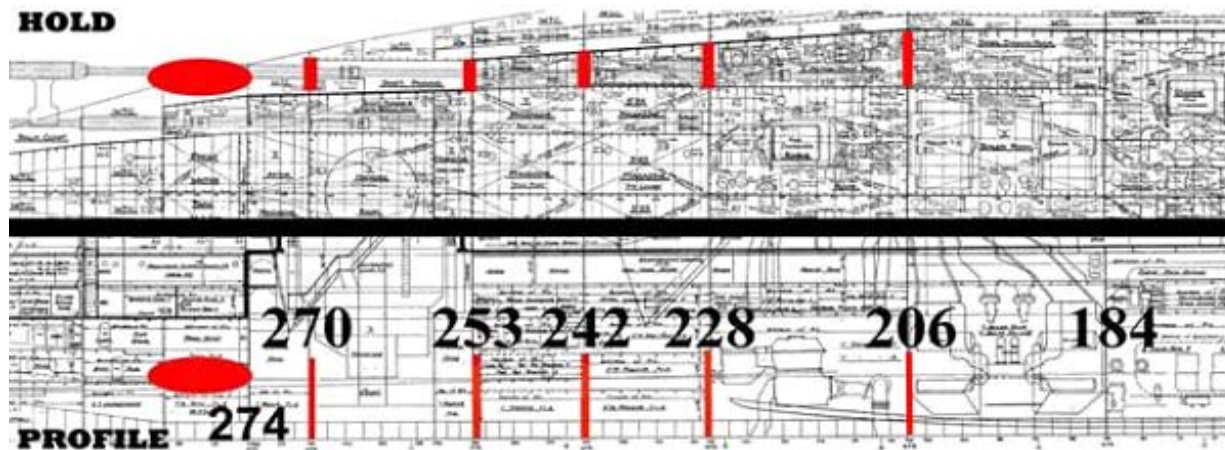
Figure 3 – Arrangement of Port Outboard Shaft Tunnel

Using Expedition ‘Job 74’ survey measurements, we can now accurately show where the torpedo in the first attack struck *Prince of Wales* (red ellipse). The red lines mark the position of the transverse bulkheads along the shaft tunnel affected by the shaft initially running out of center and then eventually disintegrating (Frames 270, 253, 242, 228 and 206). The bulkhead at Frame 184 remains intact but its gland (which cannot be viewed because of the Thrust Block Enclosure) must have failed to remain watertight as Lt Wildish reported that water flooded through it into B Engine Room.

A survivor from the Diesel Dynamo Room had even reported that its aft bulkhead (Frame 206) had “caved in”, but this has been found to be slightly in error. The shaft rotating out of center had destroyed the bulkhead stuffing gland. When inspected in 2008 and photographed in 2009 by a survey diver, the bulkhead itself was found to be relatively intact, but the gland the shaft passes through was wrecked, with the surrounding structure misshapen and elongated. When LT Wildish restarted the turbine in the ahead position, the shaft, rotating out of center, started to come loose from its remaining pedestals and bearing covers which subsequently led to the failure of the bolts connecting the 17.5-inch line shaft flanges. This situation then caused the line shaft to come apart (Figure 6) which resulted in varying degrees of destruction to the previously damaged shaft tunnel bulkheads at Frames 270, 253, 242, 228, and 206 (see Figures 3 and 11).

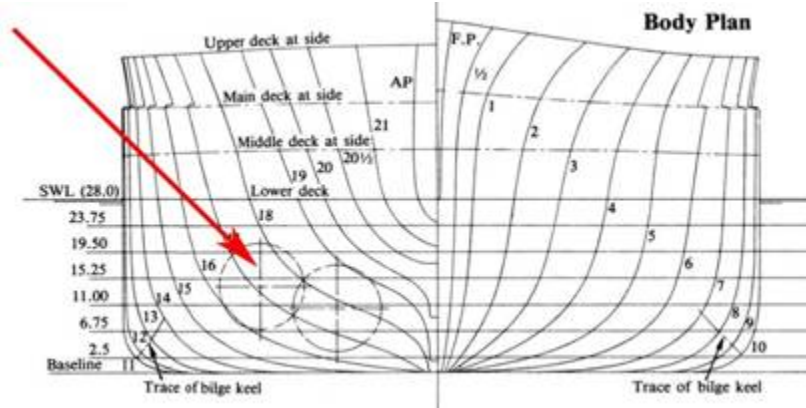
Figure 4b – Location of the Port Torpedo Hit

The red arrow above points to the approximate location of the port torpedo hit, just where the outer propeller shaft exited the hull. Note how the hull curves under where the torpedo struck the hull. This may account for why no column of water was seen to be ‘thrown upwards’ by this hit, as did occur with all the other hits.

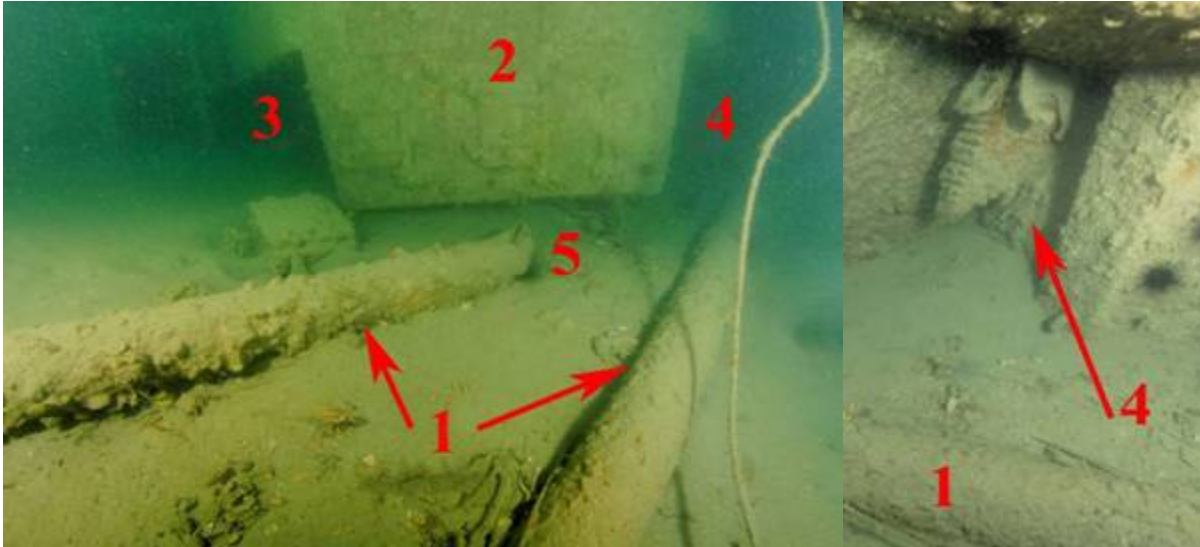
Left. The guns of S2 turret (2) have been torn out of their mounting apertures (3 & 4), caused no doubt by the guns, near maximum elevation (see image page 24), struck the seabed with the weight of the ship settling on top of them. Both gun tubes (1) lay on the seabed with torn jagged ends (5) where they ripped from the mounting. **Right.** A close up of the turret aperture (4) where one of the barrels (1) tore out from.

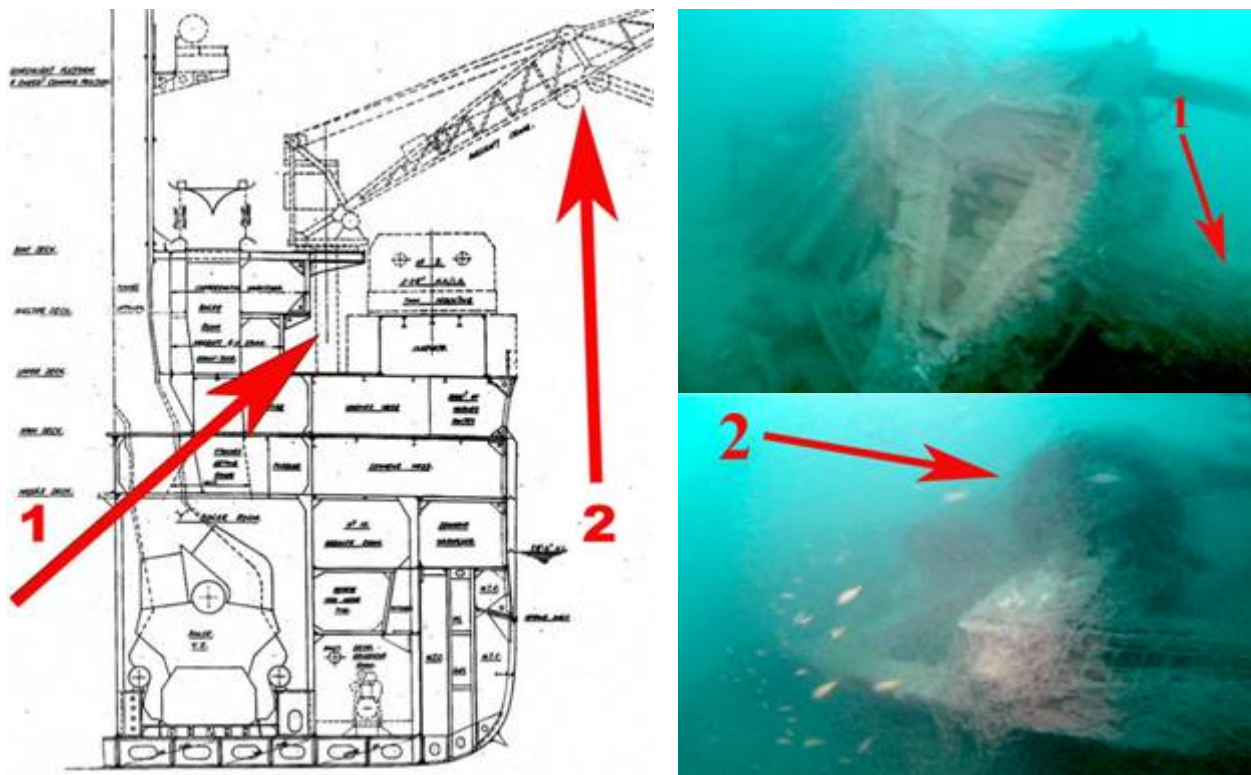
Figure 8 – Bomb Damage to the Port Aircraft/Boat Crane

below the deck in way of the catapult – in an area called the Cinema Flat – causing a bulging in the deck structure above and weakening the crane foundation.

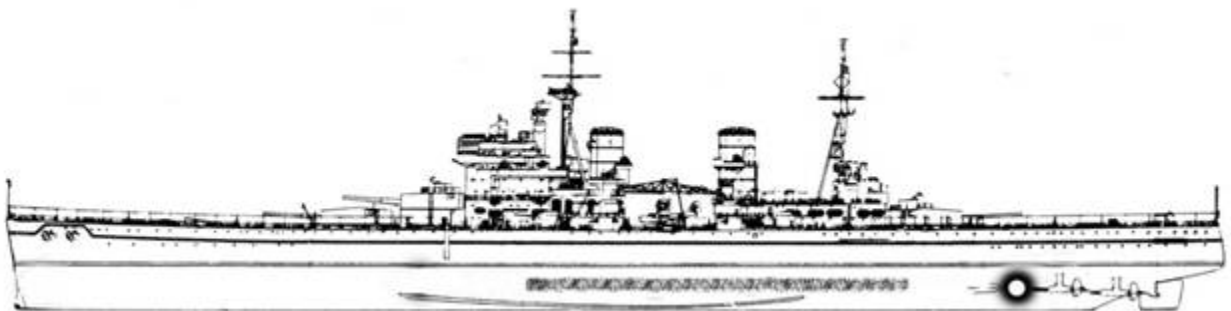
Figure 9 – Location of the Port Side Torpedo Hit

On the port side aft there is a single torpedo hole approximately 4 meters high and 6 meters long extending aft from just forward of where the outer shaft exited the stern tube gland (this hole is centered at approximately Frame 280, Figure 1):

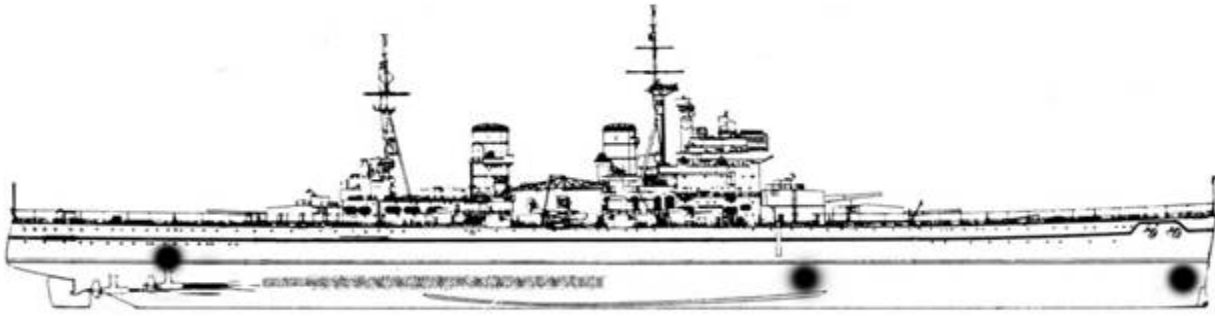
Figure 10 – Location of Three Torpedo Hits on the Starboard Side

Due to their locations on the actual side of the ship – as opposed to ‘under the ship’ as the port aft hit was - these three hits exhibited the typical venting plumes, or water columns, extending high into the air after their detonations.

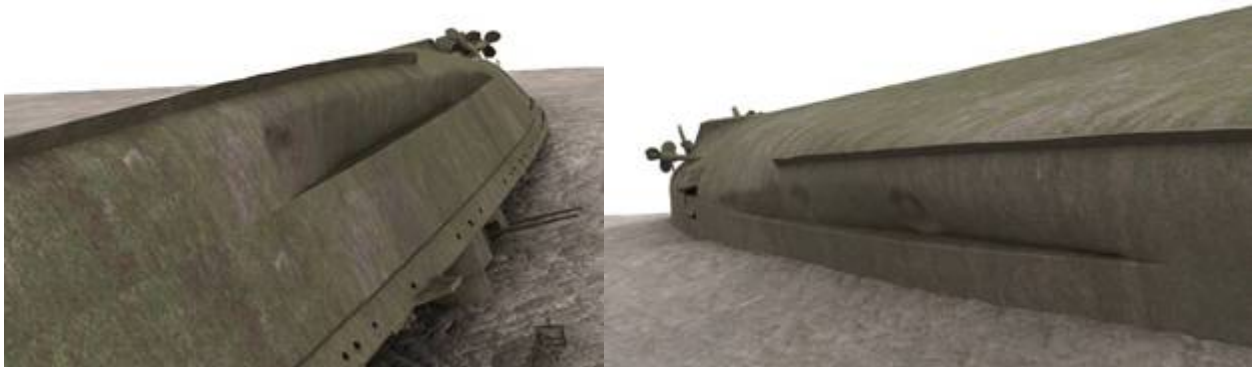
Left. Starboard side hull indentation (also see Figures 7 and 10). **Right.** Port side hull indentation (also see Figures 7 and 9).

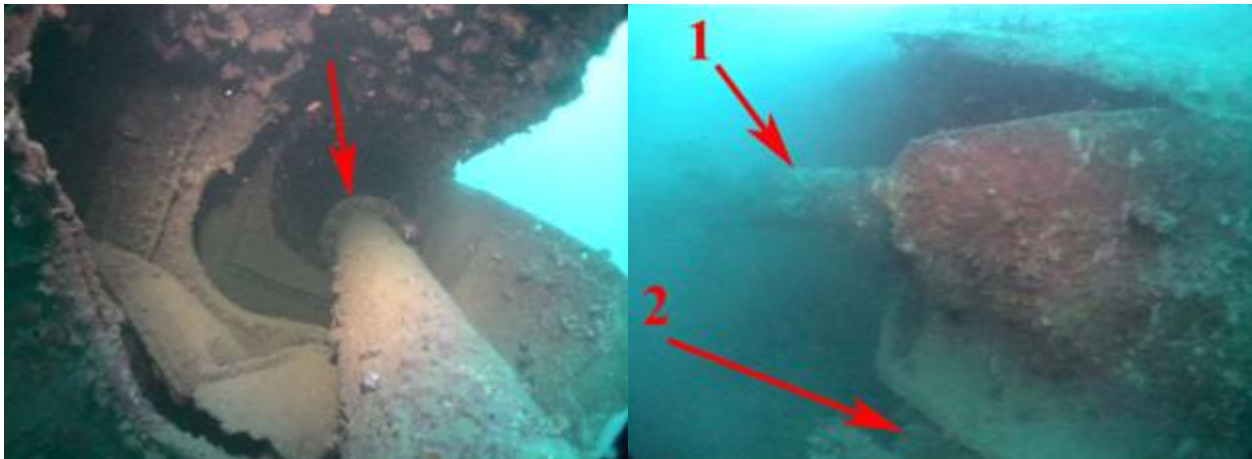
Left. Looking forward along the section of shaft that protrudes from the damaged stern tube receptacle. Note the deformed web frames that supported the stern tube and the intact flange (Flange B, lower plan position, Figure 11) that the diver maneuvered around to gain access to the shaft tunnel proper. **Right.** Viewed from 'outside' the shaft can be seen hanging down 'unsupported' (1) and a split along the hull at the base of the armour belt (2), caused by the effects of the torpedo explosion, can also be seen.

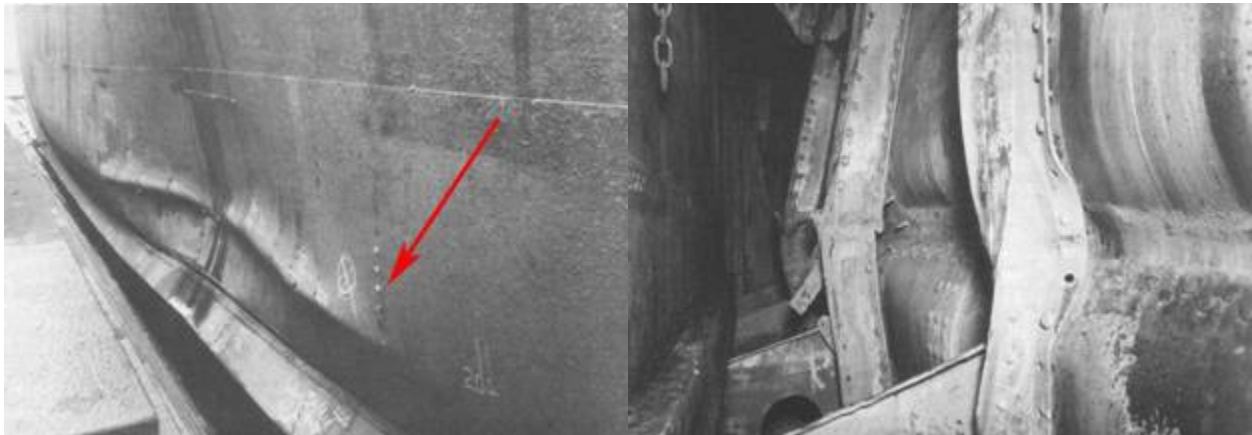
These two photos show the (German) bomb damage sustained to the port side of *Prince of Wales* while fitting out at Cammell Laird Shipyard in 1940. **Left.** Dished in hull plating stretched from Frame 184 to Frame 206 – note the plugs in the way of popped rivets (red arrow). This damage bears a direct resemblance to what has been discovered in both hull sides on the wreck. **Right.** The internal deformation in the area of the damage shown at left and is typical of a compartment of the side protection system.

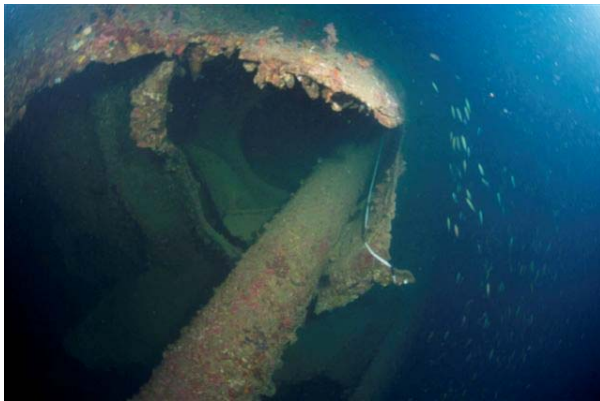
Port outer shaft where it now exits the hull. Torpedo hole is to left. Flange A is out of picture lower left.

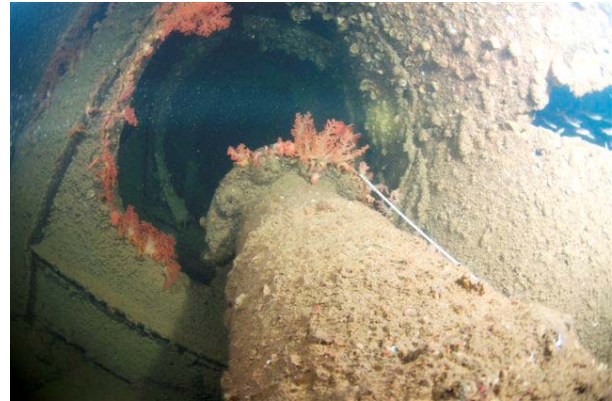
Flange B, now just inside hull where stern tube should be, is the only remaining intact flange on entire shaft.

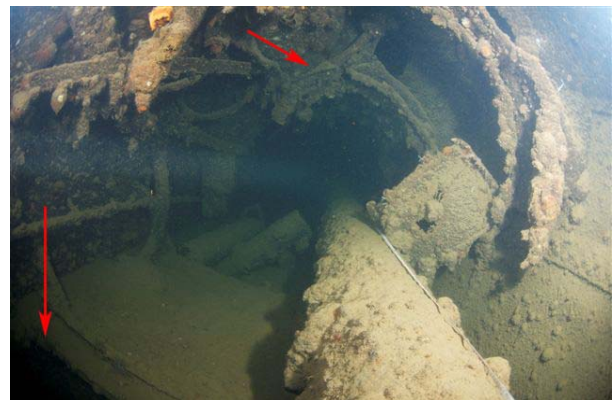
Lower arrow points to an open hatchway in deckhead, upper arrow to the remains of a Plummer Block.

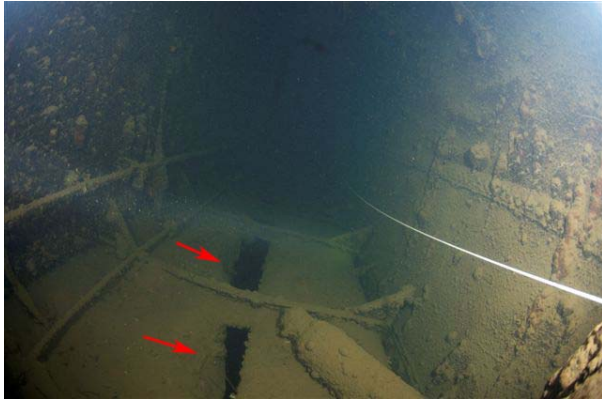
Flange C just out of picture lower right corner; start of large gap between C/C1. Note gaps in deckhead (arrows).

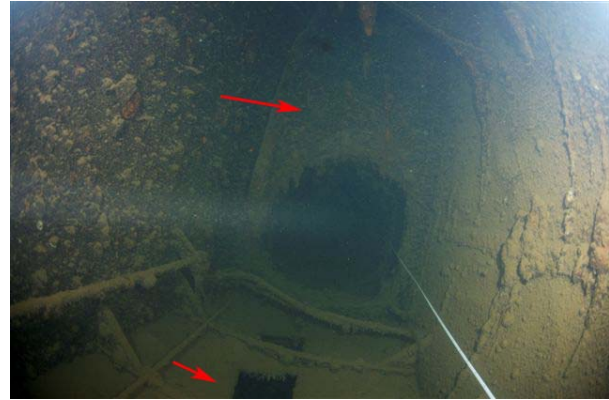
Looking towards remains of bulkhead (upper arrow) at Frame 253. Gaps in deckhead lower arrow.

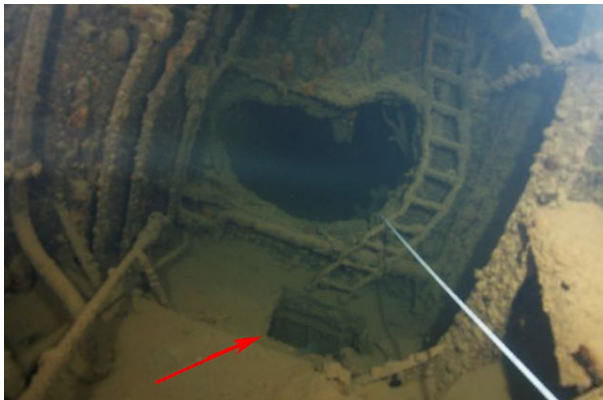
Bulkhead at Frame 242. Arrow points to an open deckhead hatchway. Another deckhead hatchway also remains open just behind (forward of) Frame 242

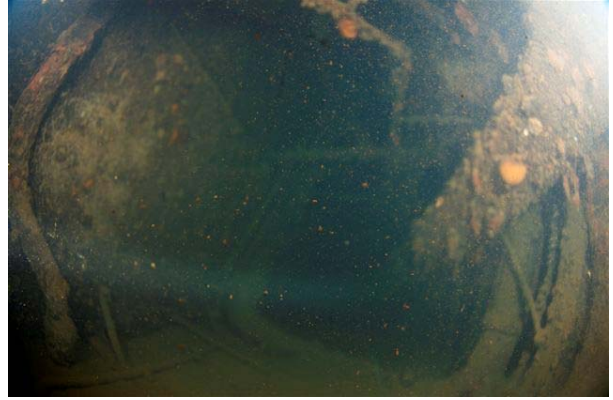
Shaft on angle at right, Flange C1 is just out of picture in upper right corner.

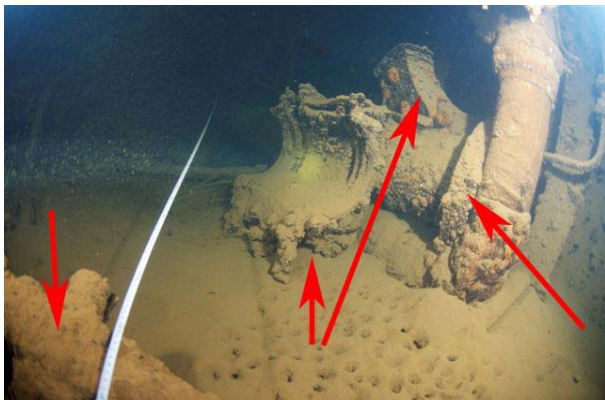
Flange D, left arrow: Remains of Plummer Block, centre two arrows: Flange D1, right arrow.

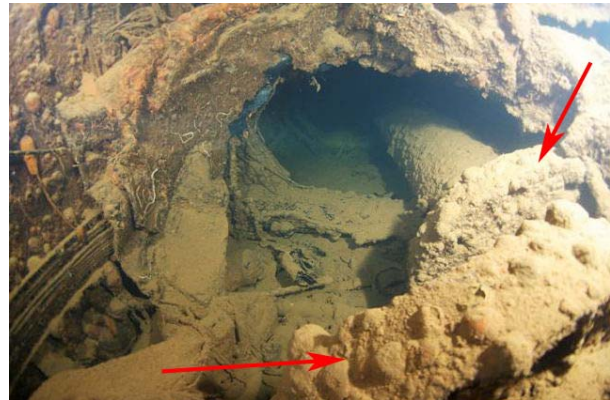
Flange E, left arrow: Flange E1, right arrow. Elongated gland in aft bulkhead to Diesel Dynamo Room (Frame 206) which survey diver squeezed through in 2009 (to continue his 2008 survey) in centre background.

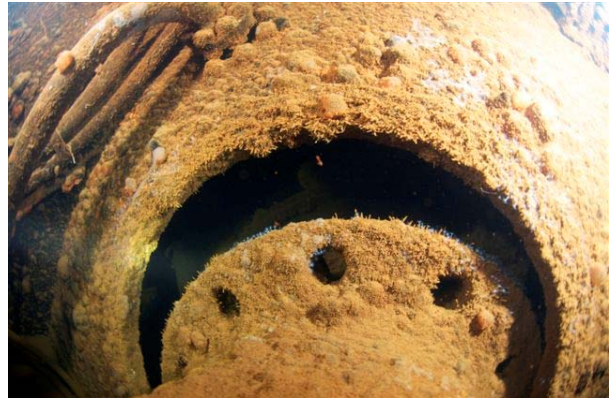
Flange F can be seen here completely 'dislocated' from the Thrust Block.
